### Investigation report No. 21/4694

Order description: Proof of flammability to classify building materials to class B1 „schwerentflammbar“ according to DIN 4102, part 1

Test samples: article: "600218 Heaven"

### 1. Method: : "Brandschacht" test accordance to DIN 4102 (1998-05)

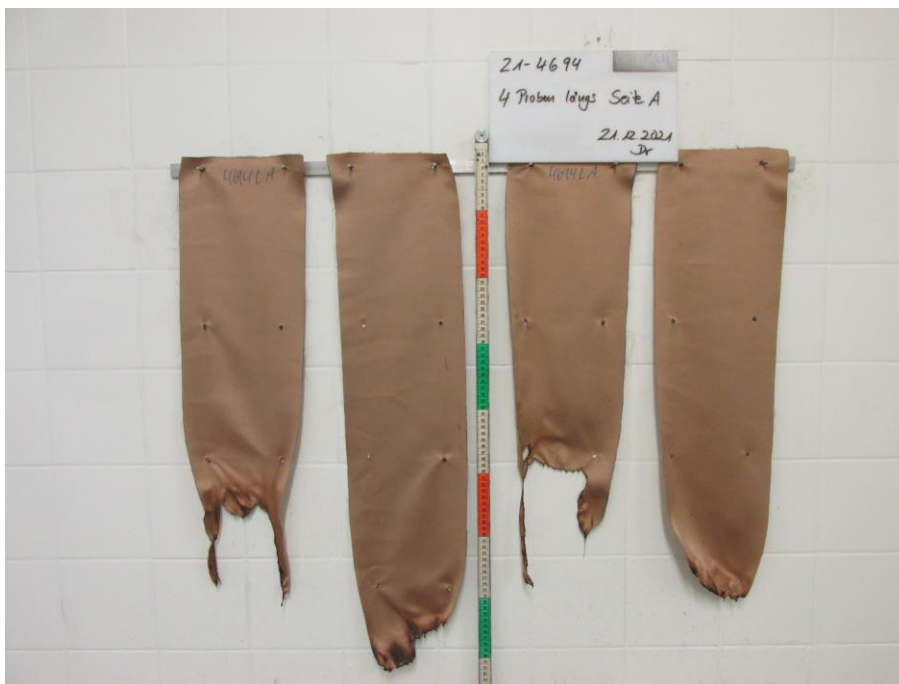
fig 2: Photo of test specimen after the test

Result with the tested specimen								
		Dim.	A	B	C					
<b>Afterflame after end of test</b>			no	no	no					
17	Time	min:s	-	-	-					
18	Number of specimen		-	-	-					
19	Front side of specimen <sup>2)</sup>		-	-	-					
20	Back side of specimen <sup>2)</sup>		-	-	-					
21	Flame length	cm	-	-	-					
<b>Afterglow after end of test</b>			no	no	no					
23	Time	min:s	-	-	-					
	Number of specimen		-	-	-					
<b>Place of appearance</b>										
25	Lower half of the specimen <sup>2)</sup>		-	-	-					
26	Upper half of the specimen <sup>2)</sup>		-	-	-					
27	Front side of specimen <sup>2)</sup>		-	-	-					
	Back side of specimen <sup>2)</sup>		-	-	-					
<b>Density of smoke</b>										
28	≤ 400% * min		57,51	35,25	63,41					
29	> 400% *min <sup>4)</sup>		-	-	-					
30	Diagram: engl. No.		1	2	3					
<b>Residual lengths:</b>										
31	Individual value <sup>3)</sup>	cm	54	73	59	64	66	55		
			45	65	44	61	48	66

32	Average value, individual test <sup>3)</sup>	cm	59	57	59					
33	Photo of specimen in enclosure no.		1	2	3					
<b>Flue gas temperature</b>										
34	Maximum of average value	°C	124,7	127,3	132,3					
35	Time <sup>1)</sup>	min:s	8:43	10:00	9:47					
36	Diagram: encl. No.		1	2	3					
37	<b>Remarks: -</b>

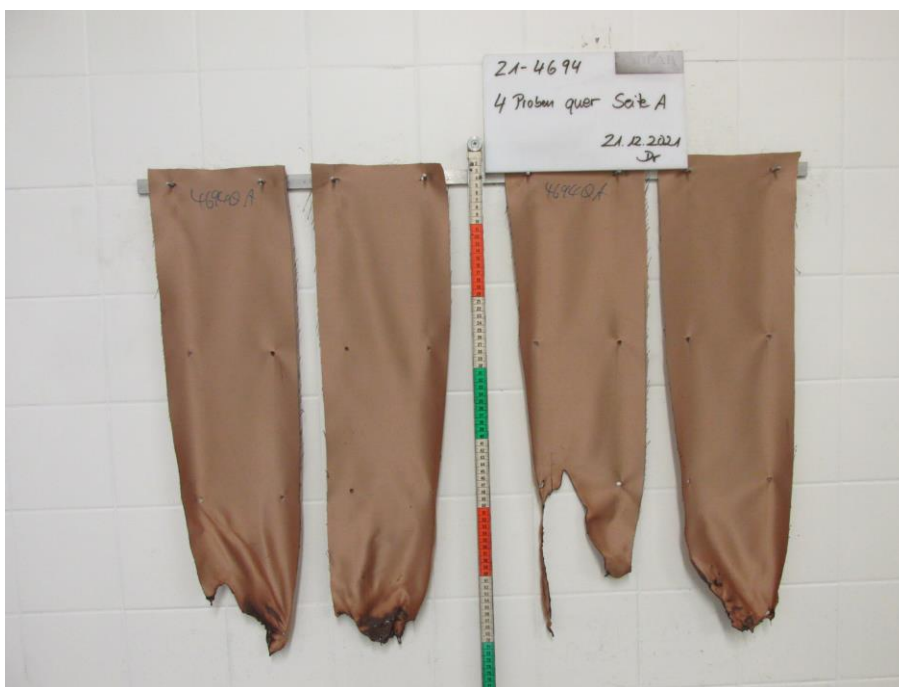
fig 2: Photo of test specimen after the test

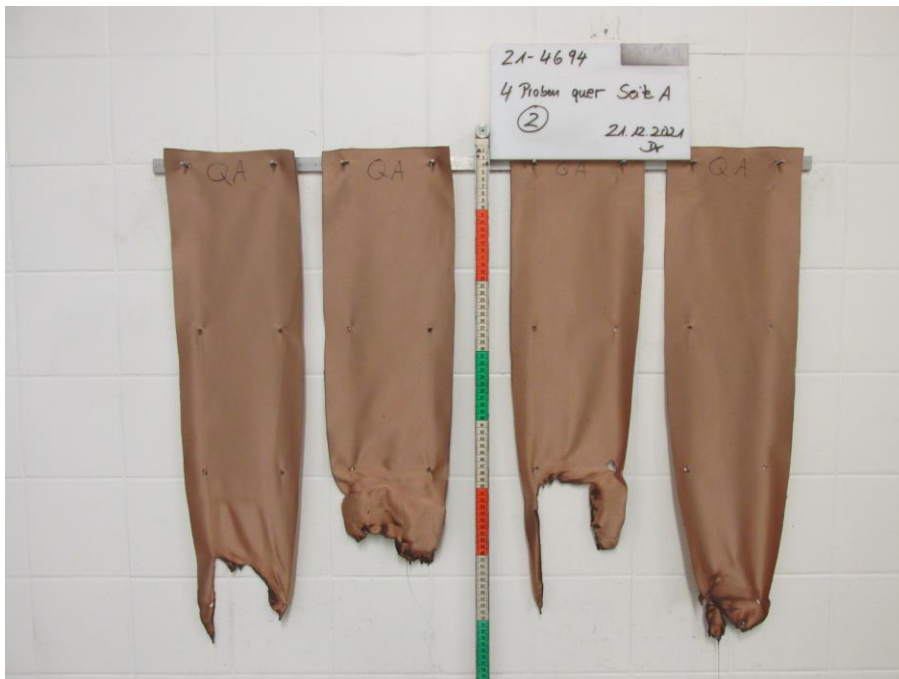
fig 2: Photo of test specimen after the test
