## Investigation report

### Investigation report No. 21/4692

Order description: Proof of flammability to classify building materials to class B1 „schwerentflammbar“ according to DIN 4102, part 1

Test samples: article: "600175 Linear"

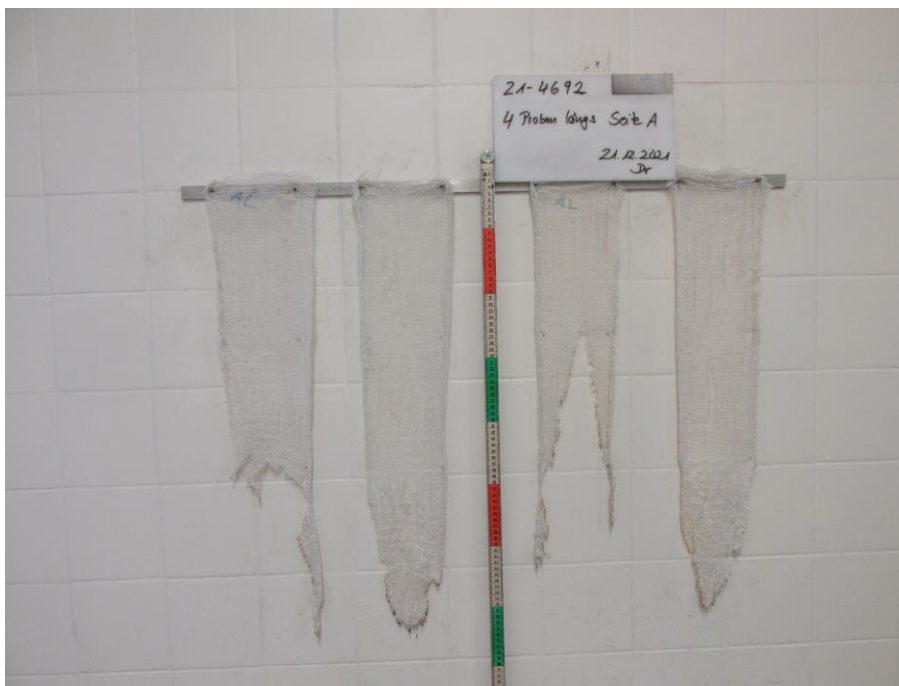
fig 2: Photo of test specimen after the test

Result with the tested specimen								
		Dim.	A		B		C		D	
<b>Afterflame after end of test</b>			no		no		no		no	
17	Time	min:s	-		-		-		-	
18	Number of specimen		-		-		-		-	
19	Front side of specimen <sup>2)</sup>		-		-		-		-	
20	Back side of specimen <sup>2)</sup>		-		-		-		-	
21	Flame length	cm	-		-		-		-	
<b>Afterglow after end of test</b>			no		no		no		no	
23	Time	min:s	-		-		-		-	
	Number of specimen		-		-		-		-	
<b>Place of appearance</b>										
25	Lower half of the specimen <sup>2)</sup>		-		-		-		-	
26	Upper half of the specimen <sup>2)</sup>		-		-		-		-	
27	Front side of specimen <sup>2)</sup>		-		-		-		-	
	Back side of specimen <sup>2)</sup>		-		-		-		-	
<b>Density of smoke</b>										
28	≤ 400% * min		51,32		71,90		60,76		46,02	
29	> 400% *min <sup>4)</sup>		-		-		-		-	
30	Diagram: engl. No.		1		2		3		4	
<b>Residual lengths:</b>										
31	Individual value <sup>3)</sup>	cm	45	63	35	53	38	58	38	57

22	62	16	58	17	55	20	54
32	Average value, individual test <sup>3)</sup>	cm	48		41		42		42	
33	Photo of specimen in enclosure no.		1		2		3		4	
<b>Flue gas temperature</b>										
34	Maximum of average value	°C	127,8		129,9		128,7		125,8	
35	Time <sup>1)</sup>	min:s	9:22		9:59		9:43		9:55	
36	Diagram: encl. No.		1		2		3		4	
37	<b>Remarks: -</b>

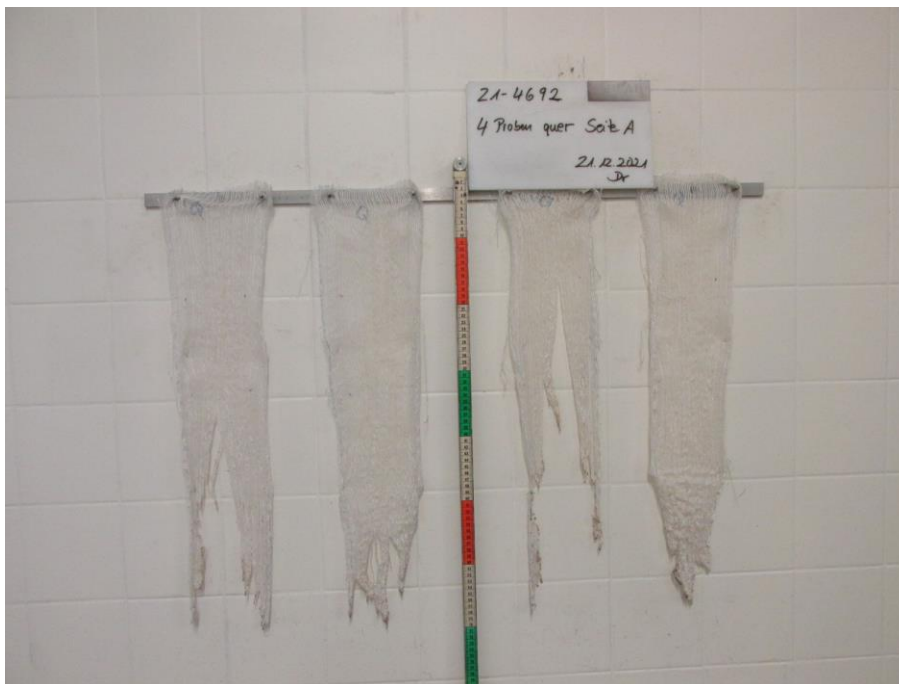
fig 2: Photo of test specimen after the test

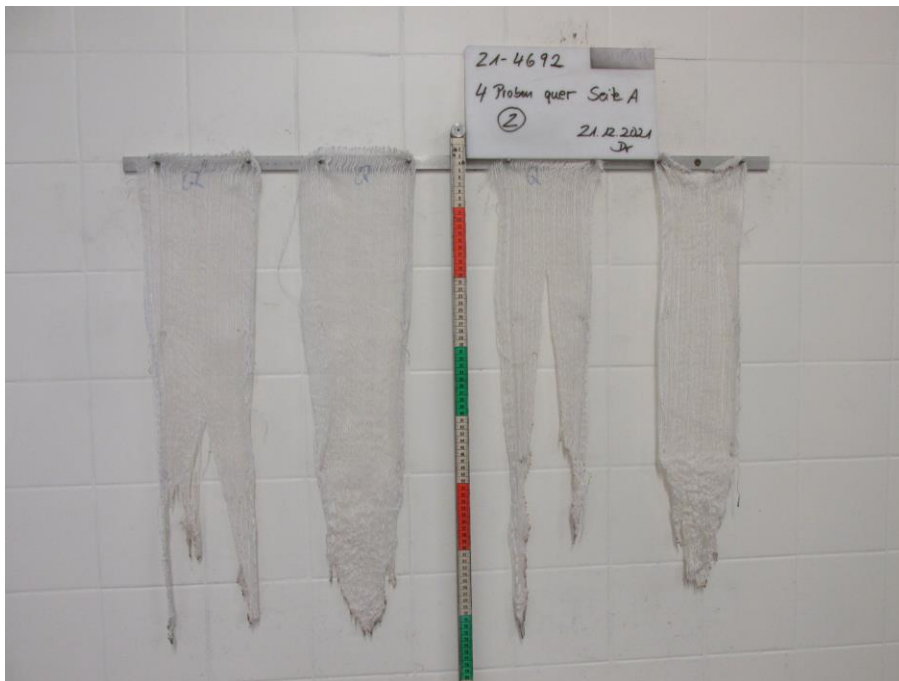
fig 2: Photo of test specimen after the test
